Recipients :	All Markets
Release date :	December 16 th , 2024
Update Purpose :	Added Enforcers guidelines
Object :	SE5000 Smart 2, Event !0D, Absence of GNSS signal for 3h of driving time

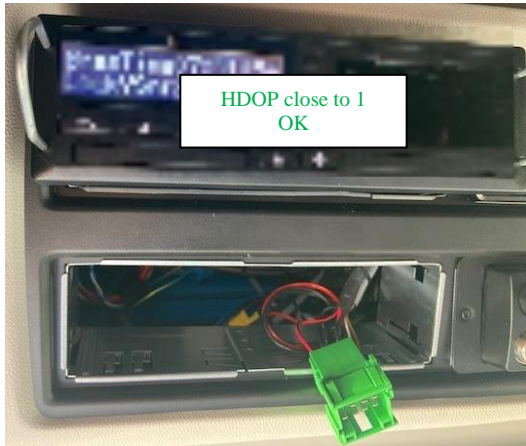
- Tolling devices,
- Telematic units,
- WLAN routers in Busses,
- Radios, Microwave, etc...
- But also ECUs with no active GSM/BT/Wifi transmission, as illustrated in below case:

Good GNSS reception

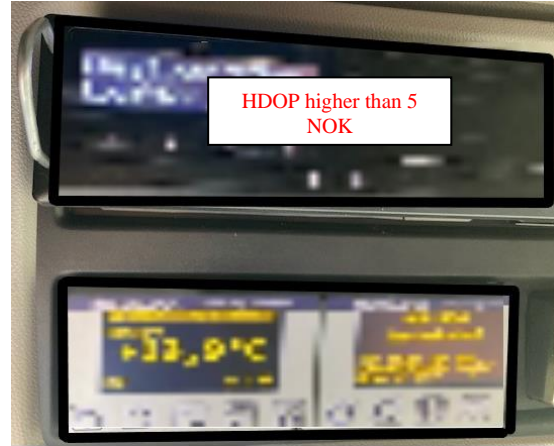
Poor GNSS reception

If an Active transmitting ECU is identified as the rootcause of the GNSS interferences:

- First, try to relocate the interfering unit,
- If not possible, please ask the manufacturer of this interfering unit whether an external GSM/Wifi antenna can be used. Install the antenna and its cable away from the tachograph.

If cables are routed behind the tachograph, they must be pushed back and secured as far off the tachograph as possible, especially coaxial cables.

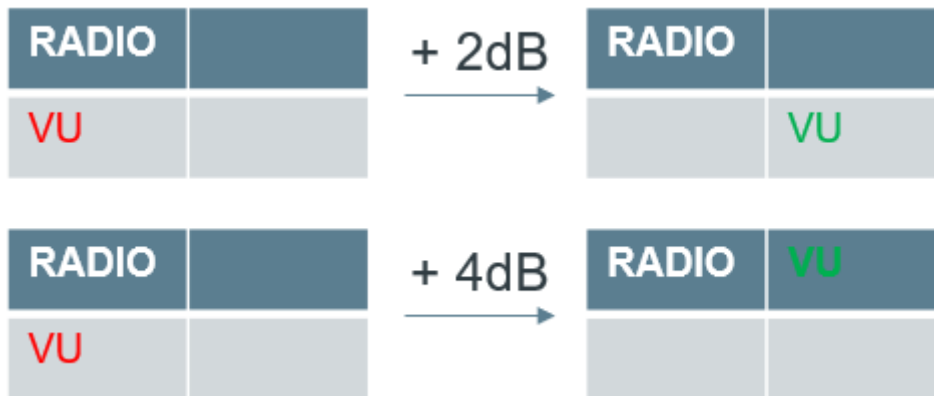
The internal GNSS Antenna is at the bottom right hand-side of the Tachograph casing. So, optimal installation for the tachograph is in the right-hand side of the upper shelf:

Important note: if any slot around the tachograph is left empty, the GNSS reception can be further improved by removing the metallic sleeve from the empty DIN slots.

Note: Avoid placing metal items less than 8 cm away from Tachograph bottom right edge.

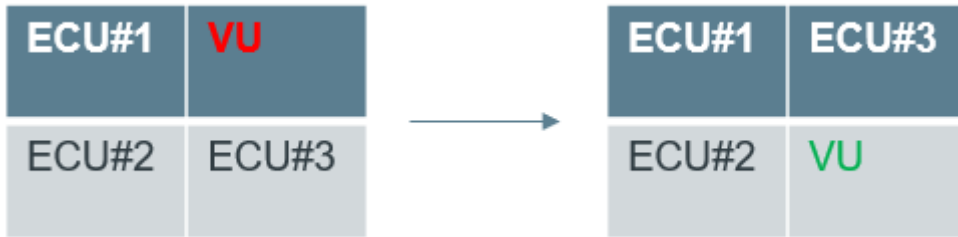
As described in the initial release of this document, dated June 15, 2024, if the 4 slots are populated, the optimal position for the Tachograph is the bottom right-hand side of the upper shelf:

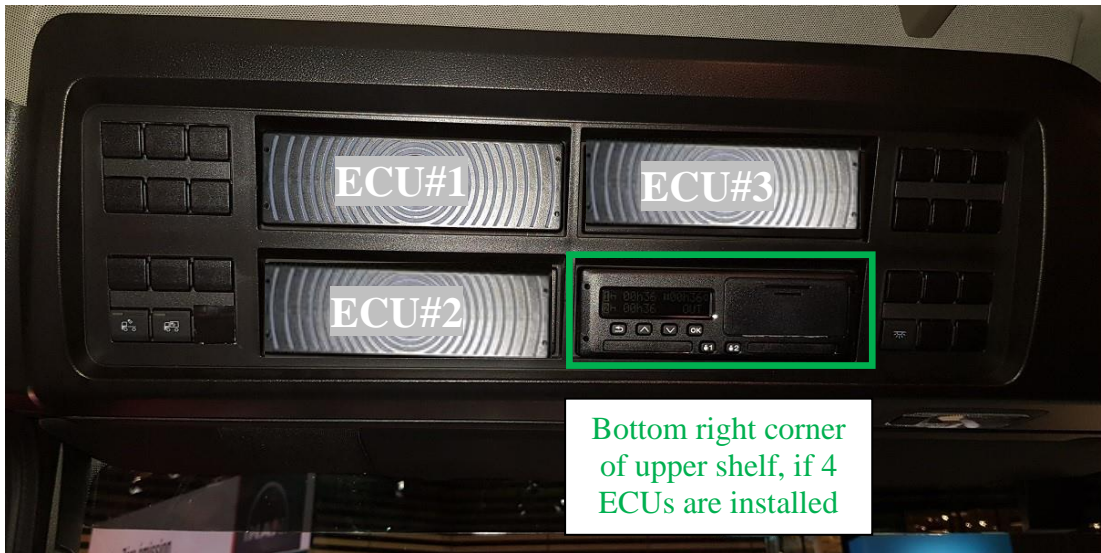
... which you can visualize in the truck as:

Note: if ECUs must be relocated, this may require seal removal from non-legal units, such as a Toll device. In which case, document this in the investigation report. Cable service loops must be long enough to allow relocating the ECU without rework; if not, contact the original installer for instructions.

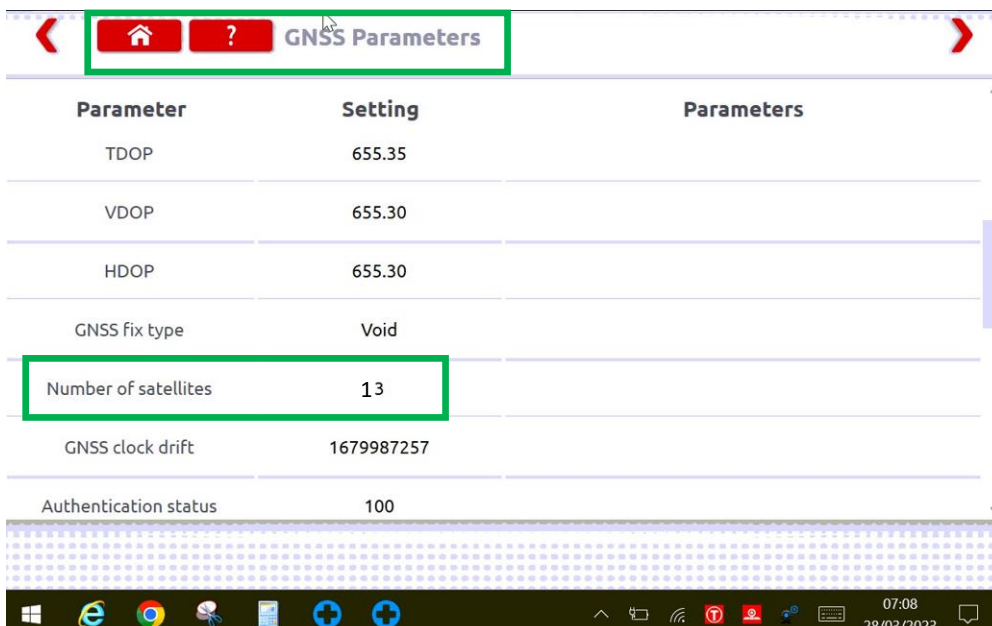
For Workshop Technician to evaluate the improvement obtained, insert card in drawer 1 and compare the number of satellites seen by the tachograph in both locations, via Optimo MKIII Application, **Read & Modify**:
